Secrets of the Ubiquitous PL-259/SO-239 Plug and Jack (aka UHF Connector)

Don Dorward, VA3DDN

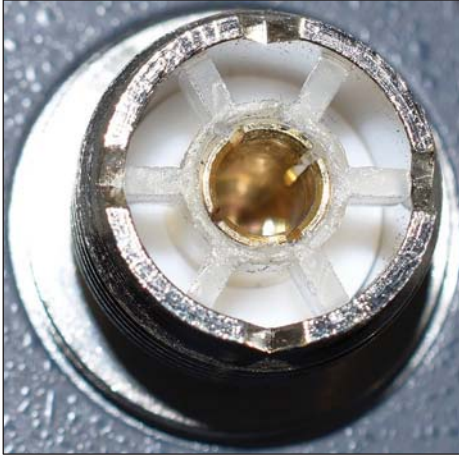
2) Impedance bump mitigation is the intent of several SO-239's that I have seen. One was on a Daiwa wattmeter as shown in Figure 5.

Figure 5: The end of a wattmeter connector with the previously solid plastic dielectric "honeycombed" in the area of the center conductor.

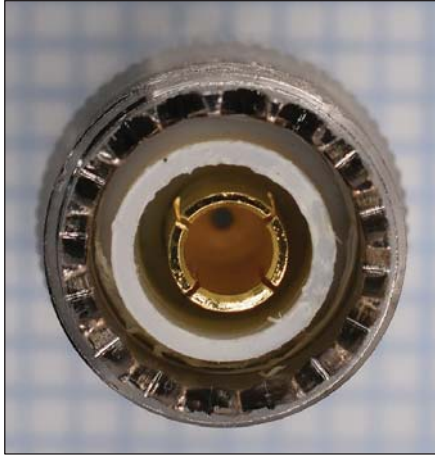
Figure 6 shows a similar approach on a short female to female SO-239 I recently purchased. Here the dielectric is "cored-out" away from the center pin. The object is to trade plastic dielectric for air, which is higher.

Figure 6: An SO-239 female to female connector with a "cored-out" dielectric.
